Geological Hazards Evaluation

**GEOLOGIC HAZARDS EVALUATION
111 CALEXICO PLACE
JASPER ROAD AND STATE HIGHWAY 111
CALEXICO, CALIFORNIA**

**Project: 111 Calexico Place Mixed Use Project
Calexico, California**

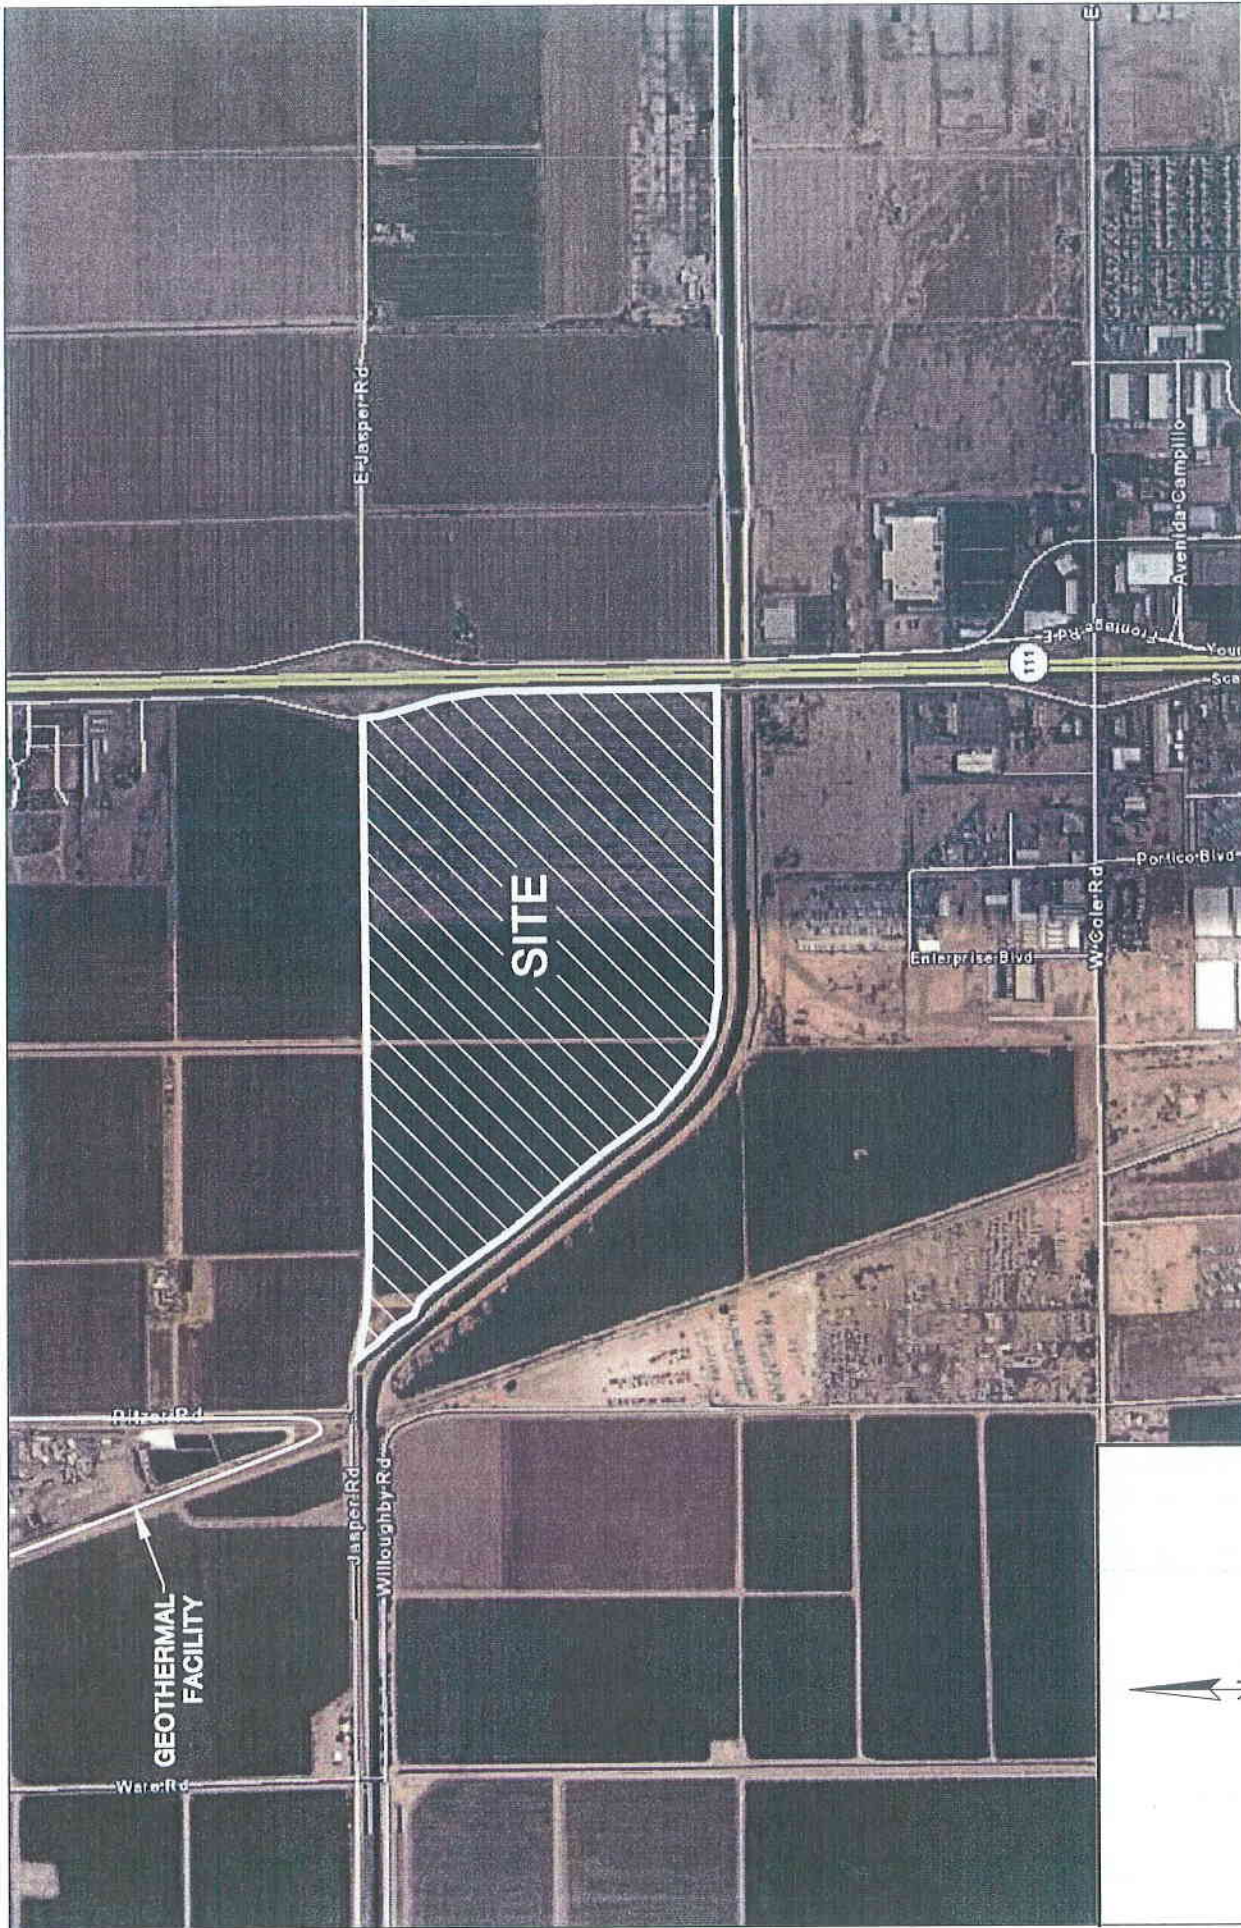
KLEINFELDER 5015 SHOREHAM PLACE SAN DIEGO, CALIFORNIA 92122		SITE MAP PROPOSED 111 CALEXICO PLACE DEVELOPMENT CALEXICA, CALIFORNIA	FIGURE <h1>2</h1>
CHECKED BY: SHR PROJECT NO. 74439	FN: 74439SITE DATE: 08/2006
